# RITE-WAY INSPECTIONS

## PROPERTY INSPECTION REPORT

8200 Crestshire Circle.

Prepared for: Jeremiah And Brandi Sphar.

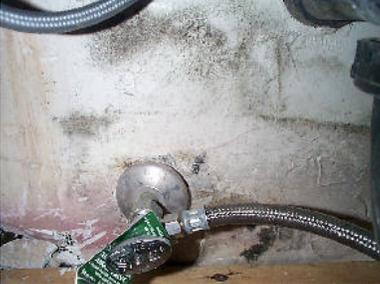
- .01 CABINETS:** **Mold was observed at the wall area. It is thought that there may be a relationship between some types of mold and some illnesses. If this is a concern, a sample of the air can be taken by your inspector and laboratory tested, for an additional fee, to determine if mold is present and which types. The cabinet bottom under the sink has been recently replaced. Recommend asking sellers if there were any adverse conditions that may have been covered over (such as mold). As an alternative, an air sample can be taken by your inspector which can determine if a hidden condition exists.**

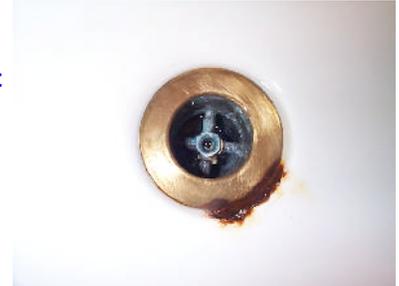
- .01 BATH VENTILATION:** The fan is operational.  
**.02 BATH FIXTURE:** A combination tub and shower is installed.  
**.03 TUB/SHOWER PAN:** General condition is fair. ( **Rust observed around the drain** ) **This will eventually leak, Suggest repair if possible and if not replacement of the tub.**

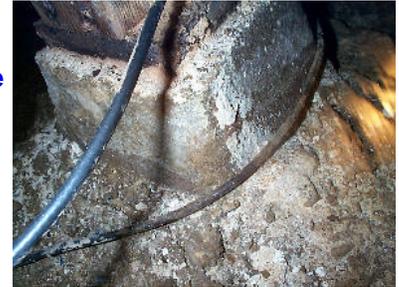
.01 ACCESS LOCATION(S):	The access hatch is in the hall closet.
.02 FOUNDATION CONDITION:	<b>Fair to poor.</b>
.03 STEM WALL:	Concrete.
.04 FOUNDATION CRACKS:	Typical hairline cracks and/or small surface voids were noted. These generally have no structural significance.
.05 ANCHOR BOLTS:	Installed.
.06 OTHER FOUNDATION OBSERVATIONS:	<b>Efflorescence was observed throughout the subarea. This is caused by moisture seeping through the concrete and maybe alleviated by improvement of the drainage. If the cause is not corrected it will damage the concrete over time.</b>

.07 FOUNDATION REMARKS:	<b>The sub area is below grade and is excessively wet. NOTE: Excessive moisture can contribute to and cause wood deterioration among other adverse conditions. Please refer to your pest report for other comments along with current repair suggestions.</b>
-------------------------	---
