RITEWAY INSPECTIONS

PROPERTY INSPECTION REPORT

578 Bridgeford Dr

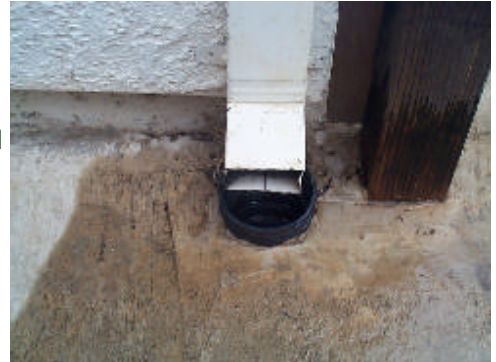
.03 ROOF DRAINAGE:

Downspouts and underground drainage piping have been used at some locations. There is a crown in the drain pipe at the right side of the house which will probably keep the line from properly draining. The testing of underground drainage systems is beyond the scope of this inspection. Please ask owner about condition or perform your own testing before the close of escrow. It is further recommended that any underground drainage system be flushed at least once a year. One of the downspouts is not connected at the right rear. This is typically an easy repair. Consideration should be given to the addition of splash blocks and/or flexible plastic downspout extensions, where they do not exist, to lead water away from the foundation.

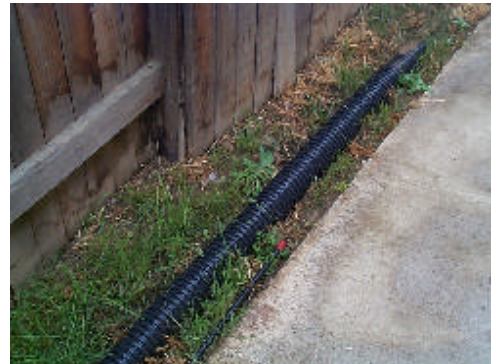
.05 UNDERGROUND DRAINAGE:

See Photo of the crowned drain pipe from the comment above

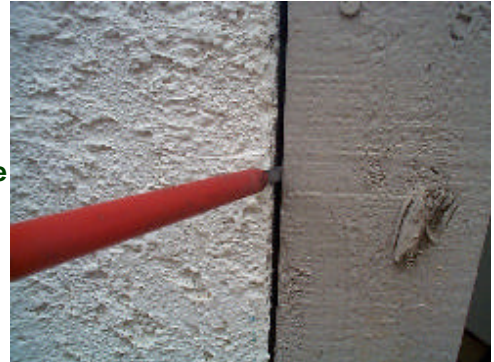
**.10 CAULKING
CONDITION:**

As a preventative maintenance we recommend caulking/sealing all voids between stucco, trim and windows to avoid the possibility of water intrusion. (See side garage door gaps where caulking is needed as an example location)

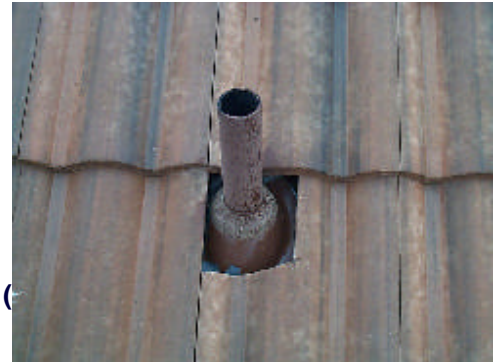
.02 ROOFING MATERIAL:	Tile/Concrete Tile. Some of the tiles have broken corners. This is a common condition and does not impair water shedding ability.
.03 ROOFING CONDITION:	The roof appears to be serviceable and functional.
.03 RIDGES:	Appears serviceable and functional.
.04 ROOF PITCH (slope):	Pitch is adequate for the type of roofing installed.
.06 LIFESPAN:	The statistical life average of this roofing product is up to 50 years.
.07 ROOFING LAYERS:	One
.08 PITCHED ROOF CONDITION:	Serviceable and functional
.09 ROOF COVERING STATUS:	Appears serviceable/within useful life
.11 ROOF PENETRATIONS:	Plumbing vents were noted One of the roof jack flashing is installed beneath the roofing material. This is not typical of most installations and can allow water to enter under the material. Recommend qualified, licensed roofing contractor for further evaluation. Suggest installing counter flashing at this location. (See colored ribbon)

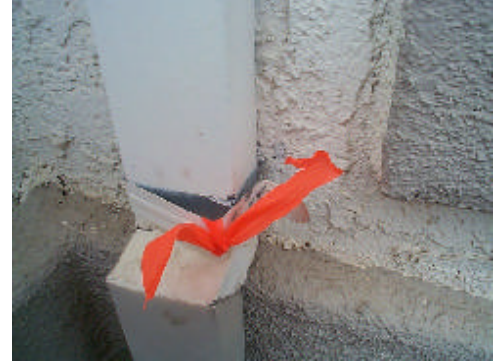
.18 DOWNSPOUTS:

Use of downspouts is good. Loose/broken downspout straps noted and some joints that need caulking at the front. This condition can be easily corrected.

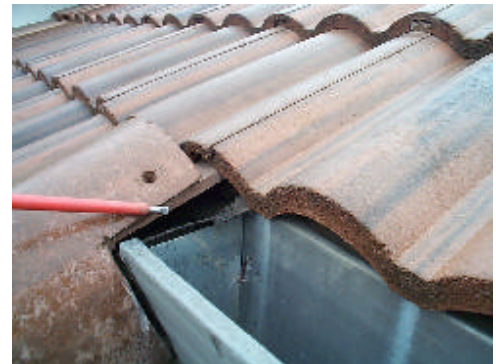
.20 ROOF REPAIRS:

There is a tile at the front of the house above the garage that is not installed so that the roofing paper is all covered. Suggest consulting a qualified, licensed roofing contractor for further evaluation/repairs. (See colored ribbon for the location)

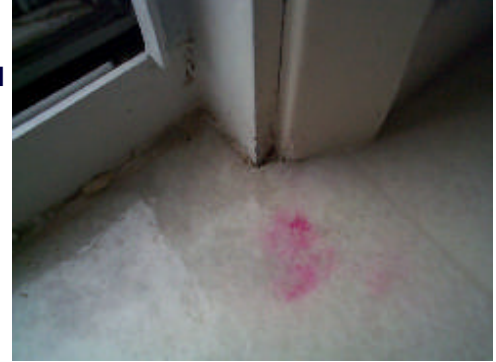
.04 FLOORING:

Floor covering is: Vinyl Noted the following conditions: **The vinyl is discolored from moisture around the patio door. (Right lower corner) This is typically caused by lack of sealant at edges during the assembly of the door frame. Suggest contacting the builder of the home as this appears to be a manufacturing defect.**

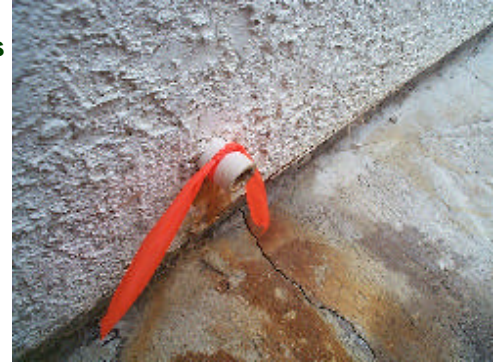
.14 OTHER CONDITIONS

Suggest adding 90 degree elbows to the condensation lines at the termination PVC pipe. See right side of the house. This condition can be easily corrected.
